CHALLENGES AND SUCCESSES OF LARGE DIAMETER TBM TUNNELING AT CANADA'S NIAGARA TUNNEL PROJECT

Lok Home
The Robbins Company, Solon, Ohio, USA

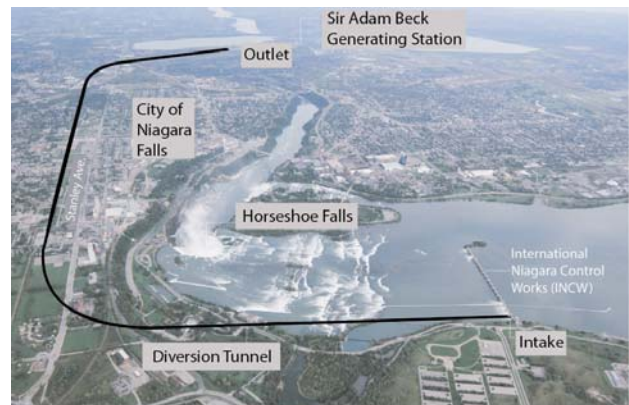
Figure 1. Original Route of the new Niagara Tunnel

Recent upgrades at the Sir Adam Beck complex have increased the efficiency and discharge capacity, and allowed the new Niagara Tunnel Project to proceed into the construction phase, which when completed will divert an additional 500 m³/s of water to the existing Sir Adam Beck generating facility (see Figure 1).

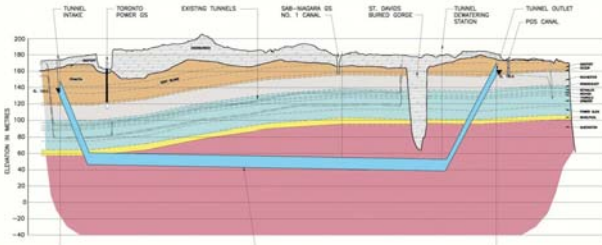
Figure 2. Geology and Original Vertical Tunnel Alignment

The new tunnel passes under the St. David's Buried Gorge, at roughly 140 m below ground surface, crossing down through the Lockport to Whirlpool Formations and into the upper 60 m of the Queenston Formation before making its ascent back toward the surface.

The Niagara Tunnel Project presents a unique opportunity to observe the Niagara sedimentary strata and allow for a more detailed understanding of the geological behavior and interaction of the heterogeneous rock units above and into the Queenston Formation (Perras & Diederichs, 2009). These rock types consist of limestone, dolostone, sandstone, shale and mudstone. The rock strength ranges from 15 to 180 MPa UCS, with most of the rock in the 40 to 100 MPa range. With the exception of sandstone, the geology is basically non-abrasive (see Figure 2).

The new tunnel was planned from the downstream end starting on OPG property at Queenston with an original alignment consisting of a - 7.82 percent decline for a length of approximately 1,400 m. Here, the tunnel proceeded with a relatively horizontal plane for a distance of approximately 7,800 m. The alignment included several 1,000 m curves. The tunnel excavation ended at the Intake in the Niagara River at the International Water Control Dam located 1.6 km upriver from the Horseshoe Falls with an incline gradient of +7.28 percent over the final 1,200 m.

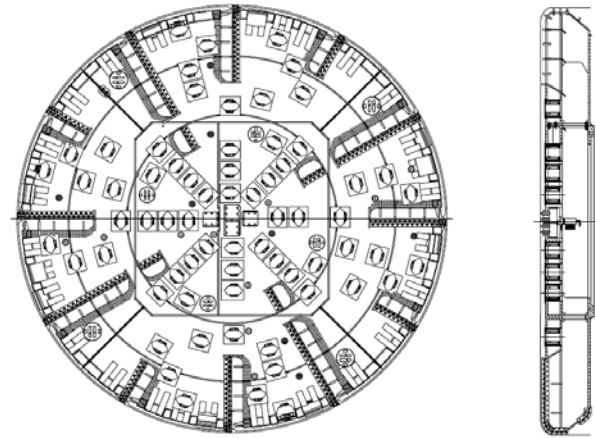
Figure 3. Niagara TBM Cutterhead

For each type of machine we would have recommended the same cutter size, cutter load, cutter spacing and bucket arrangement. In the Niagara case, 20-inch diameter cutters were chosen, setting the machine cutterhead thrust and other requirements (see Figure 3).

Again regardless of machine type the power to load the cutters and rotate the cutterhead remains the same. In the Niagara case, we selected 20-inch cutters rated to 311 kN per cutter, requiring 18,462 kN of cutterhead thrust and a torque of 18,800 kNm. While it was possible to use smaller 17-inch diameter cutters and get acceptable advance rates, larger diameter cutters were chosen because of the large number of cutters, making it important to reduce the down time related to cutter changes. Today it is generally accepted that 20-inch cutters can give approximately twice the life of 17-inch cutters.

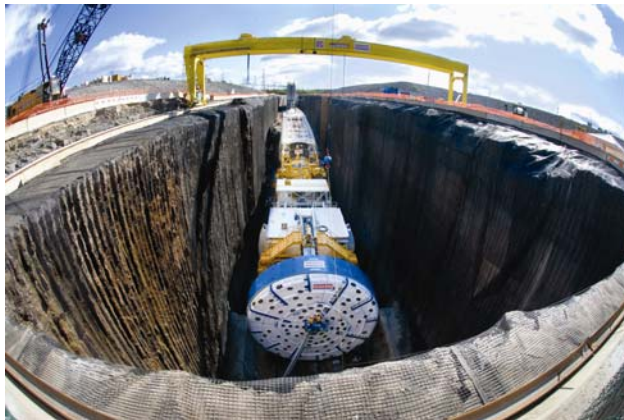
Figure 4. The 14.4 m diameter Main Beam TBM at the time of launch

This practice of jobsite assembly, known as Onsite First Time Assembly (OFTA), will be detailed in Section 8, “Actions Taken to Reduce the Construction Schedule”. The machine was launched in September 2006 (see Figure 4).

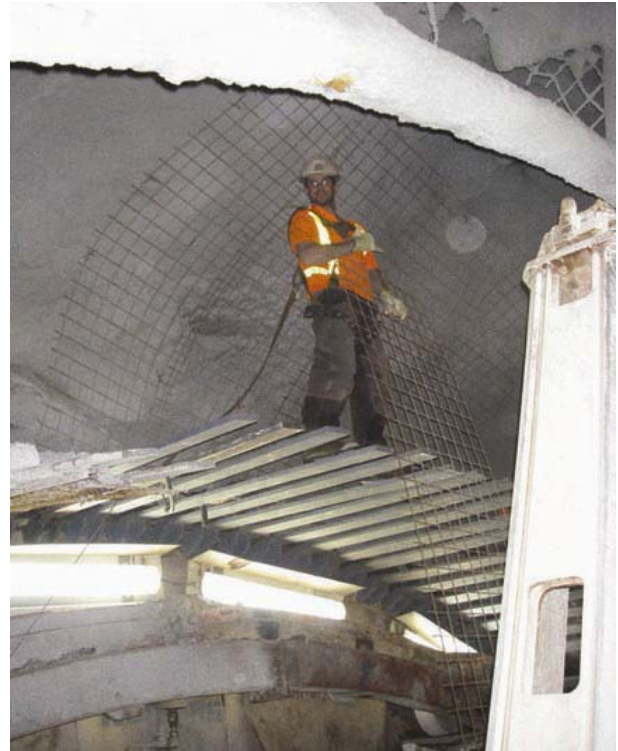
Figure 5. Over-break above the TBM, with room for a worker to stand on top of the roof shield.

This was not the case, however. When the Queenston shale was bored immediately above the cutterhead, over-break began to occur due to inherent rock stress. This initial over-break was ingested into the cutterhead opening, causing more room for over-break, which was in effect the result of the rock de-stressing (see Figure 5).

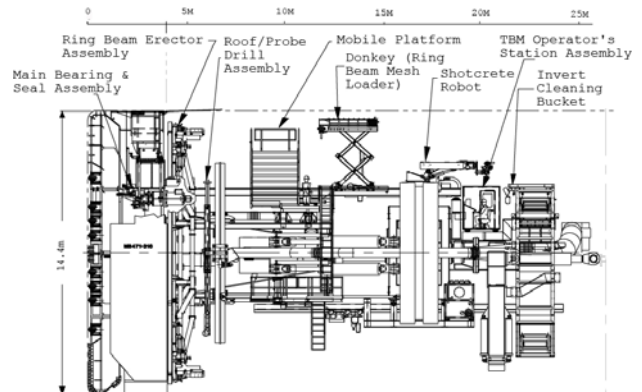
Figure 6. Original ground support set up on the Niagara TBM

Once the over-break occurred then the contractual requirement of no loose rock behind the lining came into play. The TBM was not set-up to scale down loose rock over the cutterhead or to place ground support outside the periphery of the bore. The ground support system was modified while excavation continued, from essential access by platform system to access by man bucket system (see Figures 6-7).

- A 360-degree Ring Beam Erector, which was capable of erecting two different sections of ring, rotating the sections into position and then expanding the complete ring against the wall.
- A series of platforms around the cutterhead area that allowed access for bolting the joints of the ring beam.
- A movable donkey to allow placement of straps and wire mesh in the crown area.
- Movable and stationary work platforms above the main beam for man access to assist in placing rock support.
- Rotating rock drill system with two Atlas Copco drills and booms.
- Hand-held temporary shotcrete directly behind the cutterhead area.

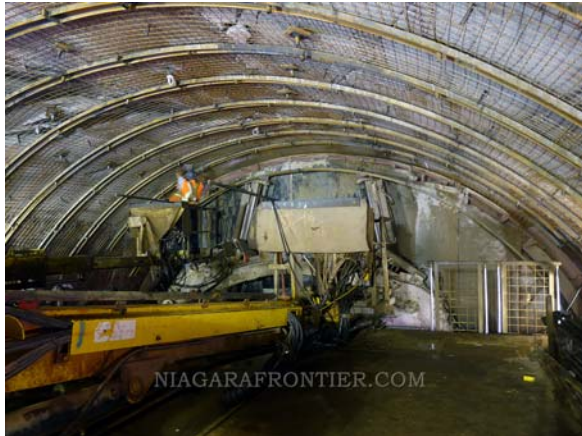
Figure 7. Revised ground support system

- Two man basket booms capable of carrying men and material (wire mesh, bolts) and shotcrete nozzleman.
- Modified original rock drill system. Full 360 degree ring beams were used in the initial decline boring; a total of 100 rings were set. The use of full 360 degree ring beams was abandoned for the following reasons:
 - They were effective if the tunnel remained round. After scaling the tunnel profile was only 60 to 70% round.
 - The ring erector device needed to be structurally strong to support the weight of the beam, and this took up too much valuable real estate immediately behind the cutterhead. Such space was needed for the more effective ground support systems.
 - Ring beams themselves are difficult to move and position in large tunnels. It is difficult to get good

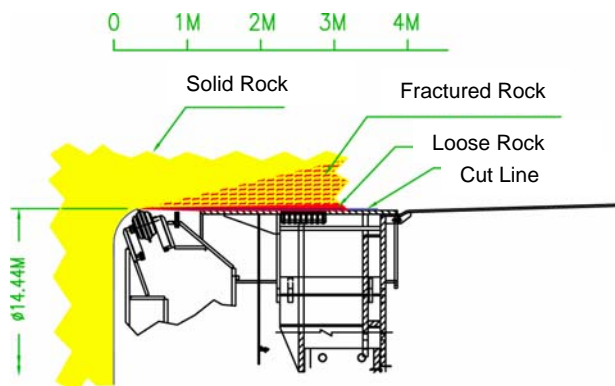
Figure 9. Setup of the gage cutter relative to the roof shield, which allowed some loose rock to fallout

The basic concept in ground support is that when loose rock exists the rock is held in place with as much support as necessary, as soon as possible. Prior to allowing "fall out" the loose rock should be made to form its own natural arch until the stress can be maintained. In the Niagara TBM case, high stresses were causing loose rock to occur in the gage area and near the gage cutters. The loose rock had space to fall out from the gage cutter to the front of the roof shield. This caused a greater loose rock volume than necessary. The distance from the gage cutter to the roof shield was greater than necessary due to the way the retraction of the roof shield was designed (see Figure 9). If we were to redesign the TBM for similar rock, we would modify the movement of the roof shield.

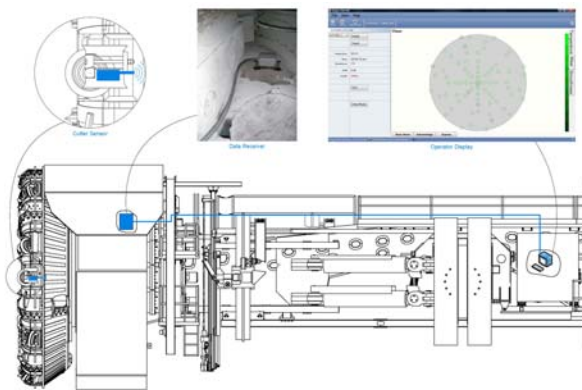
Figure 11. Cutter Monitoring System Setup

A time consuming activity related to cutters on these large TBMs is the actual time for preparing the cutterhead for inspection and crawling around the cutterhead to inspect 85 cutters. To this end, the contractor allowed Robbins to experiment with a new remote cutter monitoring system (see Figure 11).

This remote monitoring system used smart chips with signaling on the cutters and cutter housing to send data remotely outside the rotating cutterhead to a receiver in the cutterhead support. The relative wear is measured by the rotating speed of the cutter (as discs wear, rotating speed increases). If the cutter is not rotating this fact is also picked up through the same device. Cutter heat build-up is also detected, giving indications of bearing and lubrication conditions. Each cutter's instantaneous load is also detected to indicate blocky ground (in order to caution the operator to reduce cutterhead rotation speed and load).

The system was not made fully functional at Niagara but the project allowed Robbins to make good progress on this very necessary and useful technology.

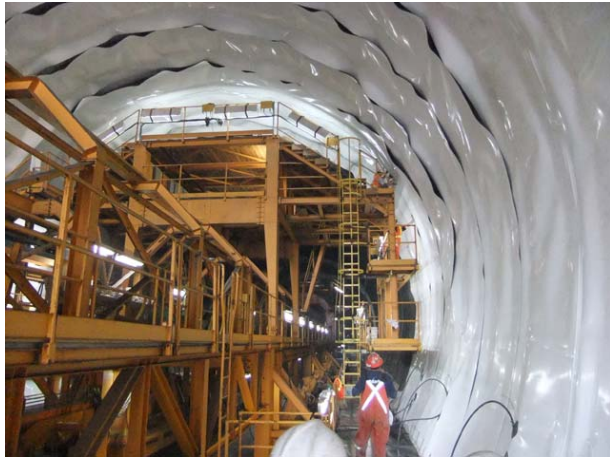
Figure 12. Waterproof Lining Installation

Behind the TBM and back-up, the water proof lining was attached to the tunnel walls. Several thousand meters behind these operations there was a crown restoration concrete operation. The final lining was done in two operations several thousand meters apart: first the invert pour and then the final pour. The complications were in moving the conveyors, ventilation and service line through the forms and the logistics of traffic. The contractor did an admirable job of planning and implementing these simultaneous processes (see Figures 12-13).

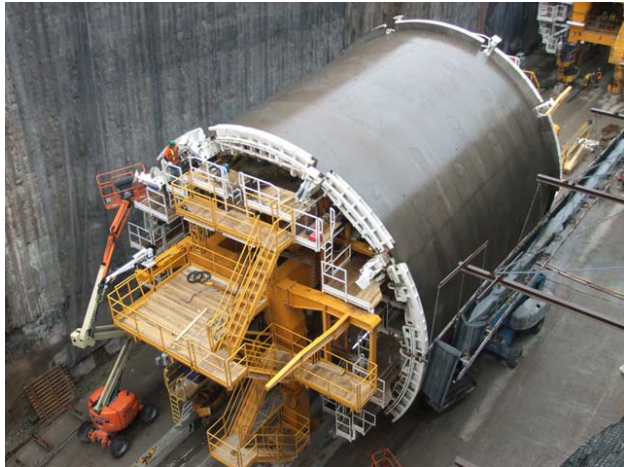
Figure 13. Concrete Lining Arch Form
