TBM Tunnelling Challenges and Managing High Groundwater Inflows on the Ashbridges Bay Treatment Plant Outfall Project

Andre Solecki, P.Eng., Kevin Waher, P.Eng., & Gary Kramer, P.Eng.
Hatch, Mississauga, Ontario, Canada
Justyna Teper, PhD., P.Eng.
City of Toronto, Toronto, Ontario, Canada

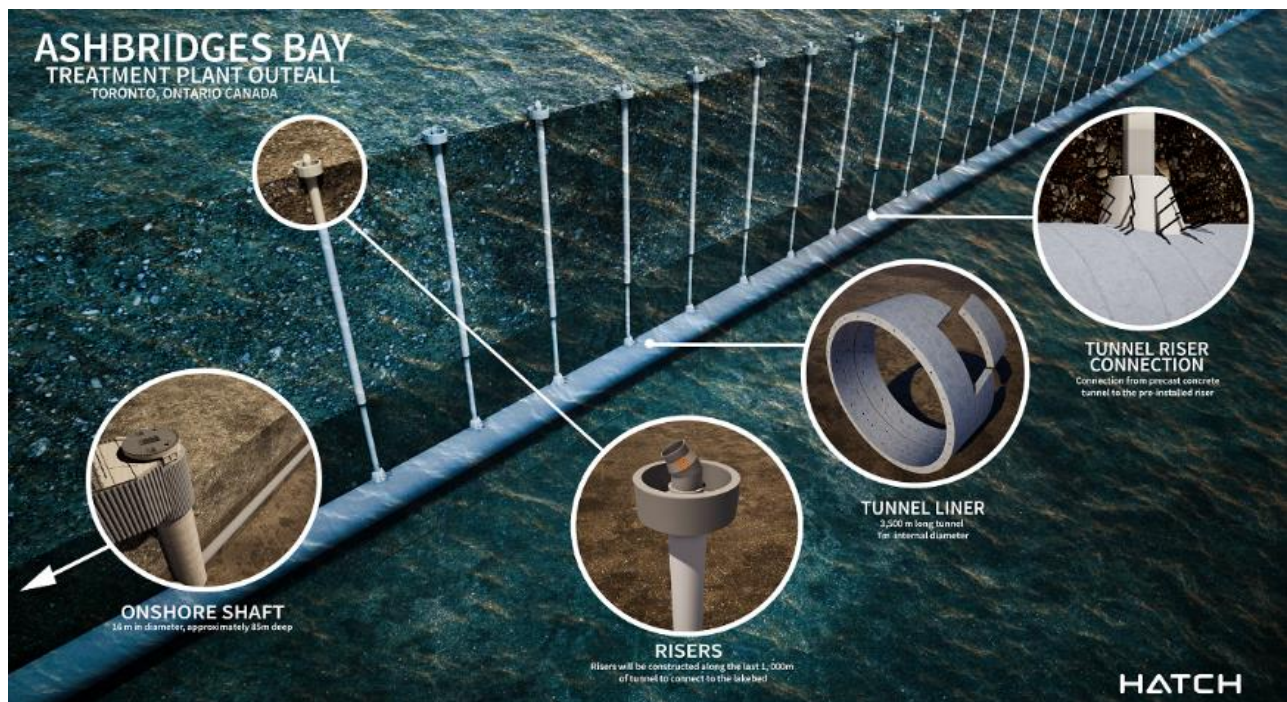
Outfall components (as illustrated in Figure 1) consist of an 85 m deep, 14 m internal diameter onshore shaft constructed adjacent to the shoreline; a 3,500 m long, 7 m internal diameter tunnel constructed through rock beneath the lakebed; and, fifty 1,000 mm diameter risers with 830 mm diameter ports installed in line with the

Figure 1. Summary of Major ABTPO Project Components

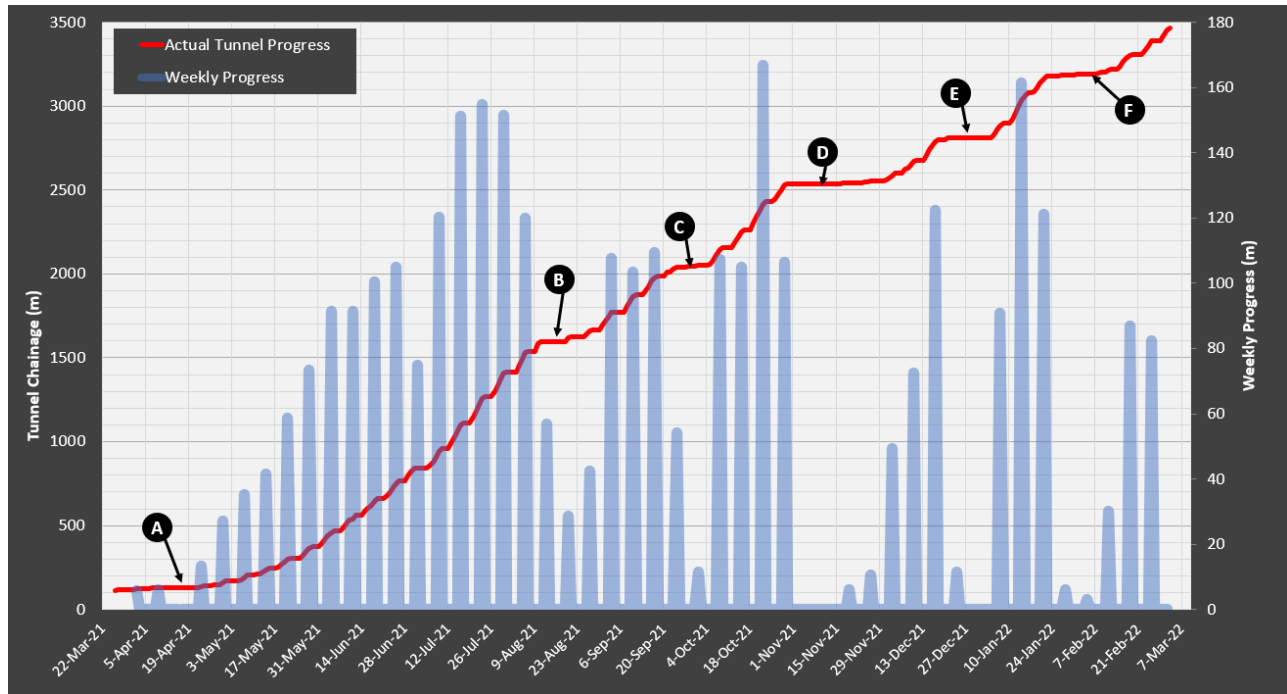
Following TBM assembly and on-site testing, initial mining commenced in late March 2021 but was briefly halted to allow the initial PCTL installed within the starter tunnel to be fully grouted. Mining recommenced on April 19, 2021 and continued until completion of the total 3,353m tunnel drive on March 2, 2022. See Figure 3 which shows the cumulative tunnel progress over time as well as the weekly totals.

Figure 3. TBM Tunnelling Overall Productivity & Weekly Advance Rates

As shown in Figure 3, the total average advance rate (including all downtime) was approximately 14.9 m per working day. During TBM tunnelling, the working day consisted of two working shifts (12 hours each) per day, 5 days per week (2 x 12 hr shifts, 5 days per week).

Figure 3 also shows major downtime events during TBM tunnelling (symbols A through F). The following summarizes these major event points:

- TBM mining learning curve and planned stopped for grouting the initial PCTL rings installed within the starter tunnel.
- Repair to TBM segment feeder cylinder, oil contamination purge, and installation of the tunnel conveyor booster station. Total downtime: 9 working days.
- Methane gas infiltration standby and pre-excavation grouting due to observed groundwater inflows during advance TBM probing. Total downtime: 3 days.
- Groundwater inflows and PCTL damages (Groundwater Inflow Zone 1). Total days impacted: 25 working days.
- Conveyor drive motor replacement and year-end holiday site shut down.
- Groundwater inflows and PCTL damages (Groundwater Inflow Zone 2). Total days impacted: 15 working days.

Section 4 describes the water inflows and PCTL damages (items D & F) in greater detail. When excluding these two specific events (which together contributed up to 40 working days), the average tunnel advance rate for the entire tunnel drive was 17.7 m per working day. Figure 3 also demonstrates that the rolling weekly advance rate was drastically impacted with encountering the high groundwater inflows during tunnelling.

During TBM tunnelling, unexpected ground conditions and high groundwater infiltration were encountered in two locations along the tunnel alignment which impacted TBM tunnel advancement and significantly damaged the PCTL. These two locations are shown as items D & F in Figure 3 and were initially encountered after 2,500m of successful mining. The following section summarizes the conditions encountered, the impacts it caused during TBM mining, and the innovation methods implemented to successfully mine through these challenging zones.

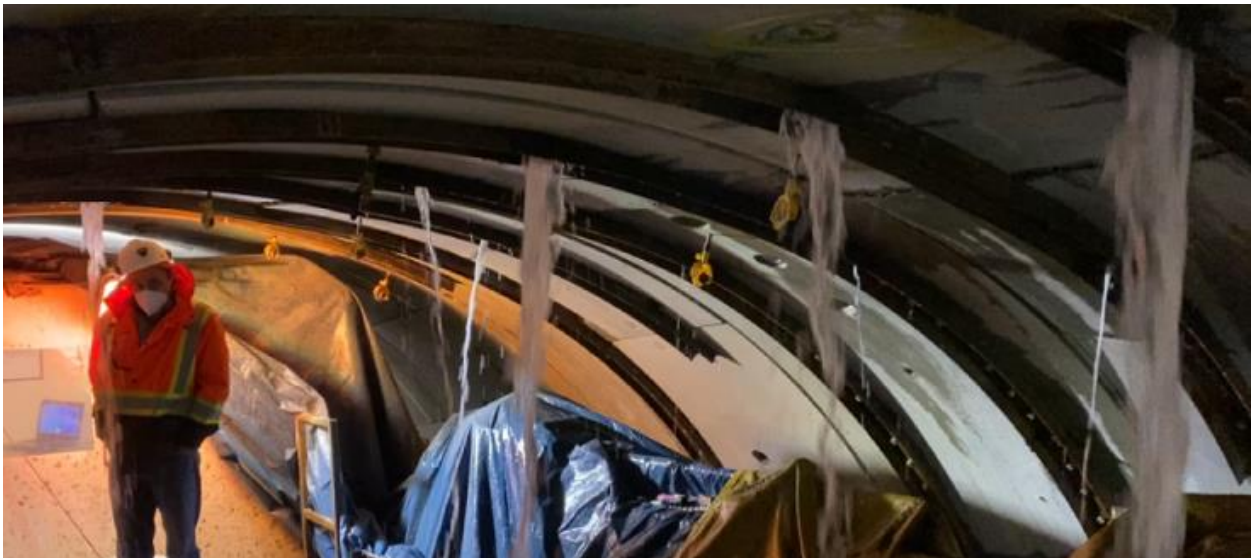
During mining in these two zones, high groundwater inflows (>400 lpm) were observed flowing through the TBM cutterhead and through the rock mass behind the PCTL lining. Refer to Figure 4 which shows the high groundwater inflows through various relief holes drilled through the PCTL. A sustained water inflow in excess of 100 lpm was measured per hole. The holes were left to drain and there was no evidence of reduced flow over a period of time. It was therefore contemplated that water inflows could have a direct connection to the lake above the tunnel alignment. At these locations, the ground conditions consist of approximately 15m of GBSF rock cover above the tunnel and 35m of overburden deposits. The distance from tunnel springline to lake level was approximately 70m. In some holes, packers were installed to confirm groundwater pressures ranging between 25 to 45 PSI (1.7 to 3.1 Bar).

Figure 4. Significant Groundwater Inflow from the Rock Formation above the Tunnel Crown

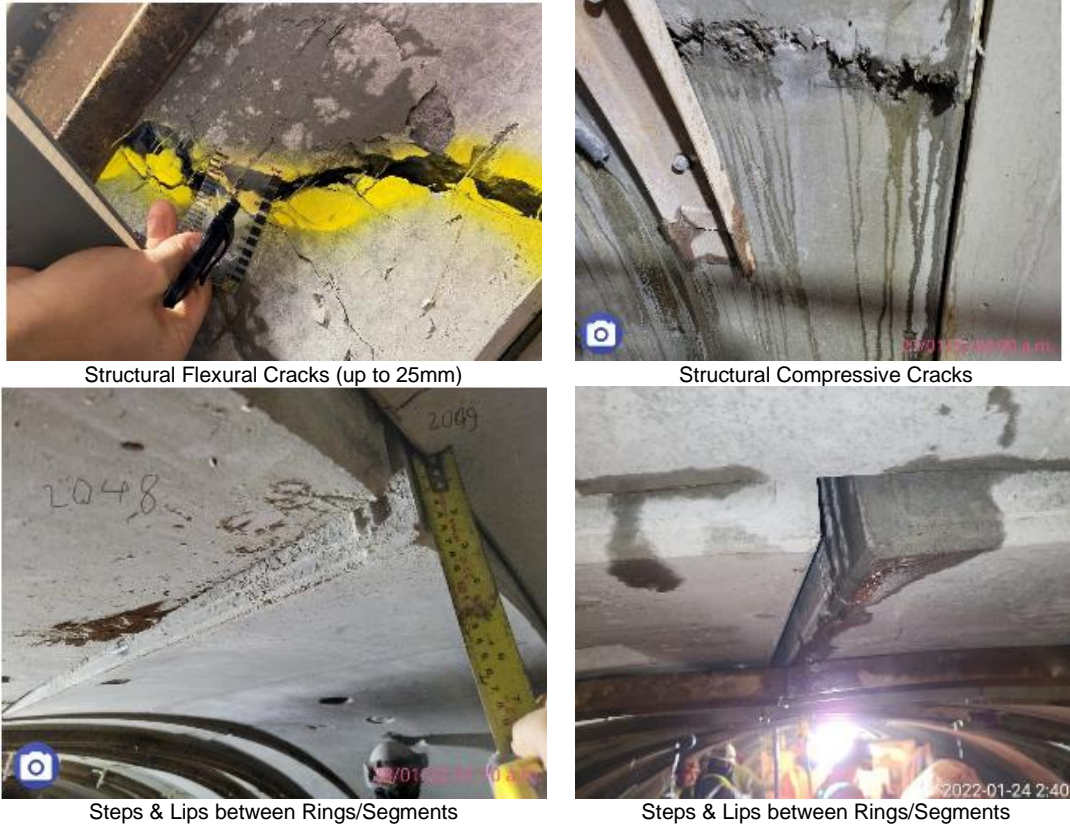
When these conditions were first encountered, damage to the PCTL lining occurred in the crown of the tunnel consisting of structure cracks (>25mm in thickness) and movement to the rings (steps & lips) as shown in Figure 5. Upon investigation it was concluded that the high groundwater inflows washed away the specified two-component PCTL annulus grout, creating a void in the PCTL annular gap. It was concluded that the lack of lateral support around the ring due to the grout wash-out resulted in a loss of lateral confinement and support to the PCTL. Due to an annular gap (approximately 150mm) between the PCTL O.D. and the TBM excavated diameter, the PCTL ring squatted until the lateral deformation reached the rock surface (nominally at tunnel springline). Due to the squatting of the ring, the PCTL now acted as an arch and the additional bending and tensile forces in the ring caused the PCTL to crack. Refer to Figure 6 for illustration of the conditions which led to the noted damages.

Figure 5. Representative Example of PCTL Damages During Encounter High Water Inflow Events

Once the high-water inflows and initial PCTL damages were first encountered, the contractor was directed to temporarily stop TBM mining to allow the designer to assess the conditions and integrity of the PCTL tunnel. It was determined that additional PCTL repair was necessary consisting of crack repairs, channel installation within the crown, and rock bolt installations. The rationale for this required repair was to stabilize the rings to ensure axial load transfer was restored in the ring. Two channels per segment (C150x12.2) nominally spanning between the 10 o'clock to 2 o'clock position were installed to temporarily stabilize the segments. Depending on the damage segment and the orientation of the installed ring, up to 6 bolts per segment (1.8m in length and 32mm OD injectable anchors using TPH TD Solid Seal TX Resin) were installed.

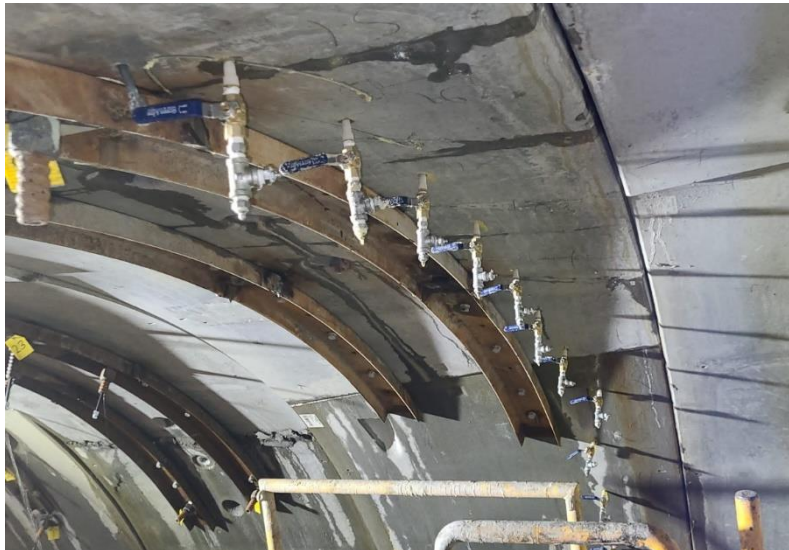
Figure 8. Chemical Grout Collar Radial Injection Ports to Stabilize Ring along with Steel Channels

1. Install a chemical grout collar around the first ring immediate outside the TBM shield. In total approximately 50-70 drill holes were installed around the complete ring, with approximately 2 to 4 L of chemical grout injected per hole. See Figure 8.
2. Mine and build next ring while carefully examining movements and damages to nearby rings. During TBM mining, continue with injecting two-component annulus grout through the TBM shield while increasing the B-component accelerant.

3. Pre-install channel supports on the ring built within the TBM shield. It was determined that the pre-installation of channel supports prior to the ring leaving the TBM mitigates segments damages, lips and steps in the event that PCTL moves further due to lack of annulus confinement.
4. Monitor PCTL damages and have material and equipment available to repair segments as needed (crack repairs, rock bolts, additional channels, etc.).
5. Perform additional check holes and proof grouting using both the two-component grout and chemical grout. Ensure all segments are stable and the annular gap is full prior to mining the next ring set.
6. Repeat the pattern until the TBM successfully mines through the encounter ground feature.

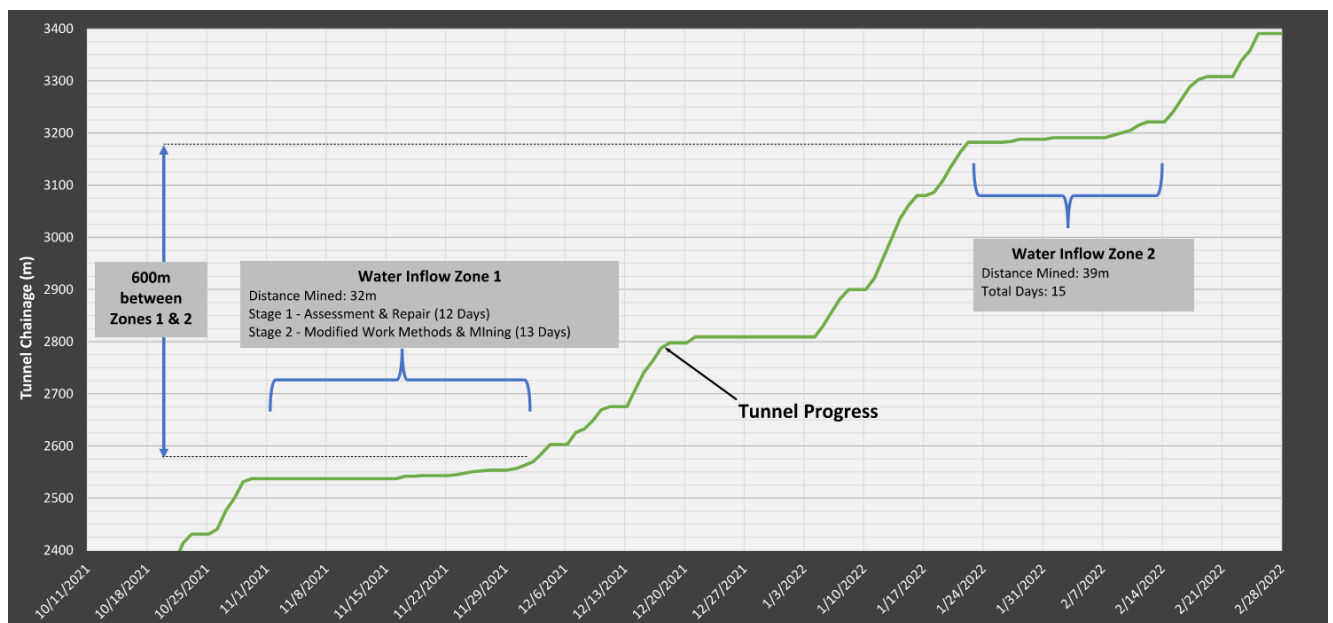
Figure 9. Time-Chainage Plot during TBM Mining Through Water Inflow Zone 1 & 2

The alternative work methods were collaboratively developed while considering diverse concepts and ideas brought forward by the entire project team including site supervisors, foremen, engineers, from all Contract parties (Contractor, Consultant, and Owner). Although the alternative work methods reduced daily tunnel advance rates, the plan did allow TBM to safely resume through the challenging ground conditions. Figure 9 demonstrates the overall TBM advancement during this challenging period.

As shown in Figure 9, the initial water inflows resulted in 12 working day standby as the site team investigated the condition, remediated the tunnel lining, developed alternative work method and procured new materials and equipment. The first zone was found to be approximately 35 m in length and mining through this zone progressed at a rate of 1.3 m/day. The second zone was approximately 39 m in length and the average productivity to mine through this zone was 2.6 m/day which is twice as fast as the first zone. The increase in productivity is attributed to the learning curve and readiness to implement the alternative mining method developed in the first zone.
